## BAT SURVEY REPORT

Brady's Pub site on the Old Navan Road, Dublin 15

SEPTEMBER 17, 2019

BARTRA PROPERTY (CASTLEKNOCK) LIMITED.

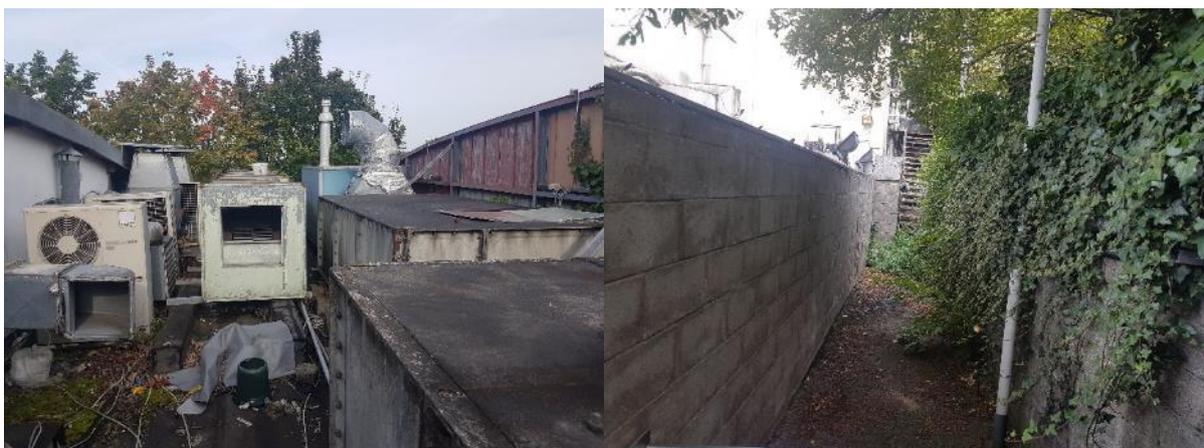
To the rear of the building a flat roofed area contains rooftop water tanks and air conditioning units. The corrugated wall sheeting sits above the building creating an unroofed walled in space (**Plate 3-5 and 3-6**). A cavity noted from the wall on the north-west side opened to the floor space here showing no potential for roosting bats.

Plate 3-5 Upper flat roofed section    Plate 3-6: Alley leading to rear entrance

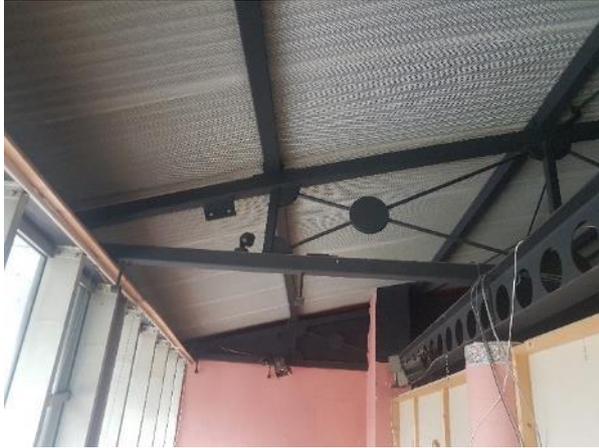
Plate 3-7: Upper floor section 1

The upstairs of the building is divided into two distinct sections. Section 1 (see **Figure 2.2**); a storage area showed no signs of bats and very limited potential for bat access into the space. Section 2; a former restaurant had potential access from a broken window and a section where roof sheeting had

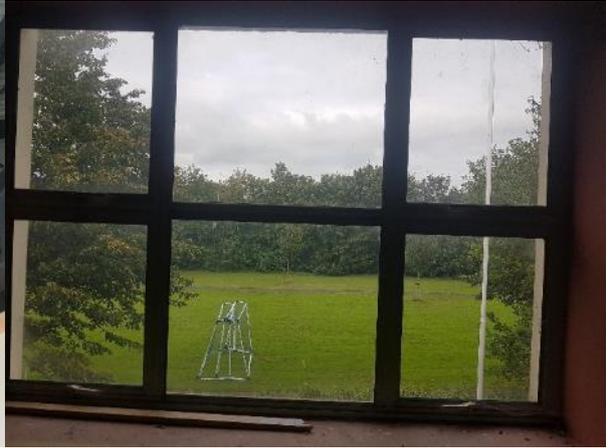
Plate 3-8: Windows showed no signs of previous bat presence

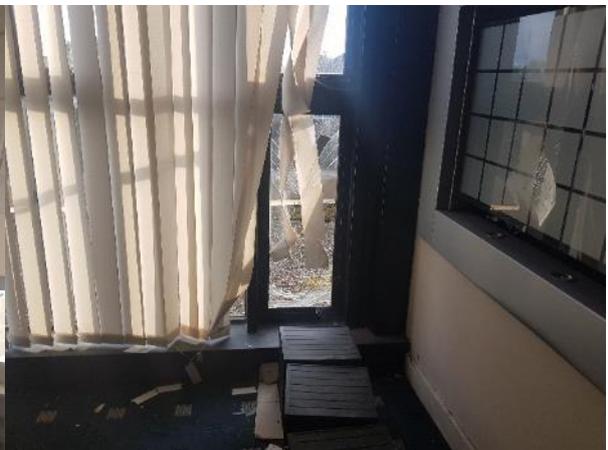
Plate 3-10: Broken window

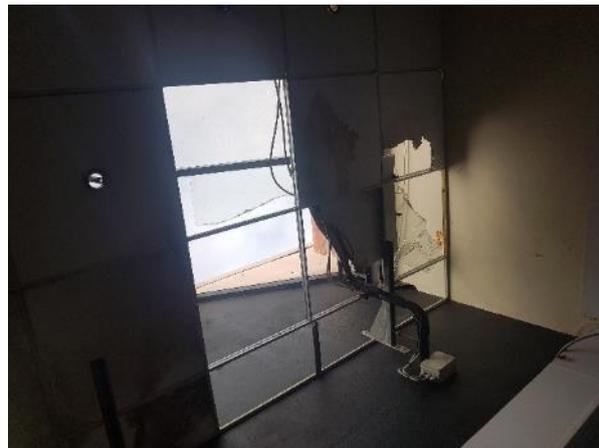
Plate 3-11: Broken roof section

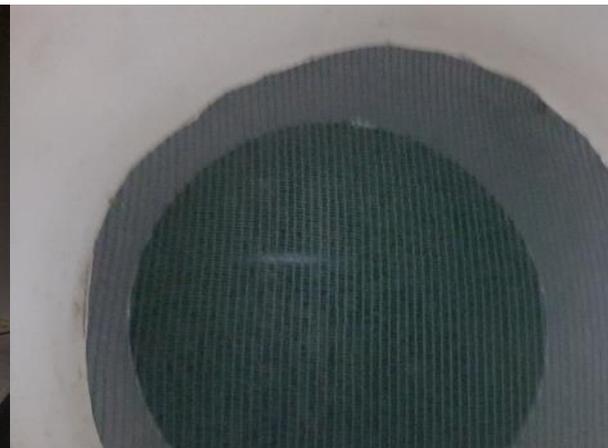
Plate 3-12: Vent pipes had mesh preventing access.

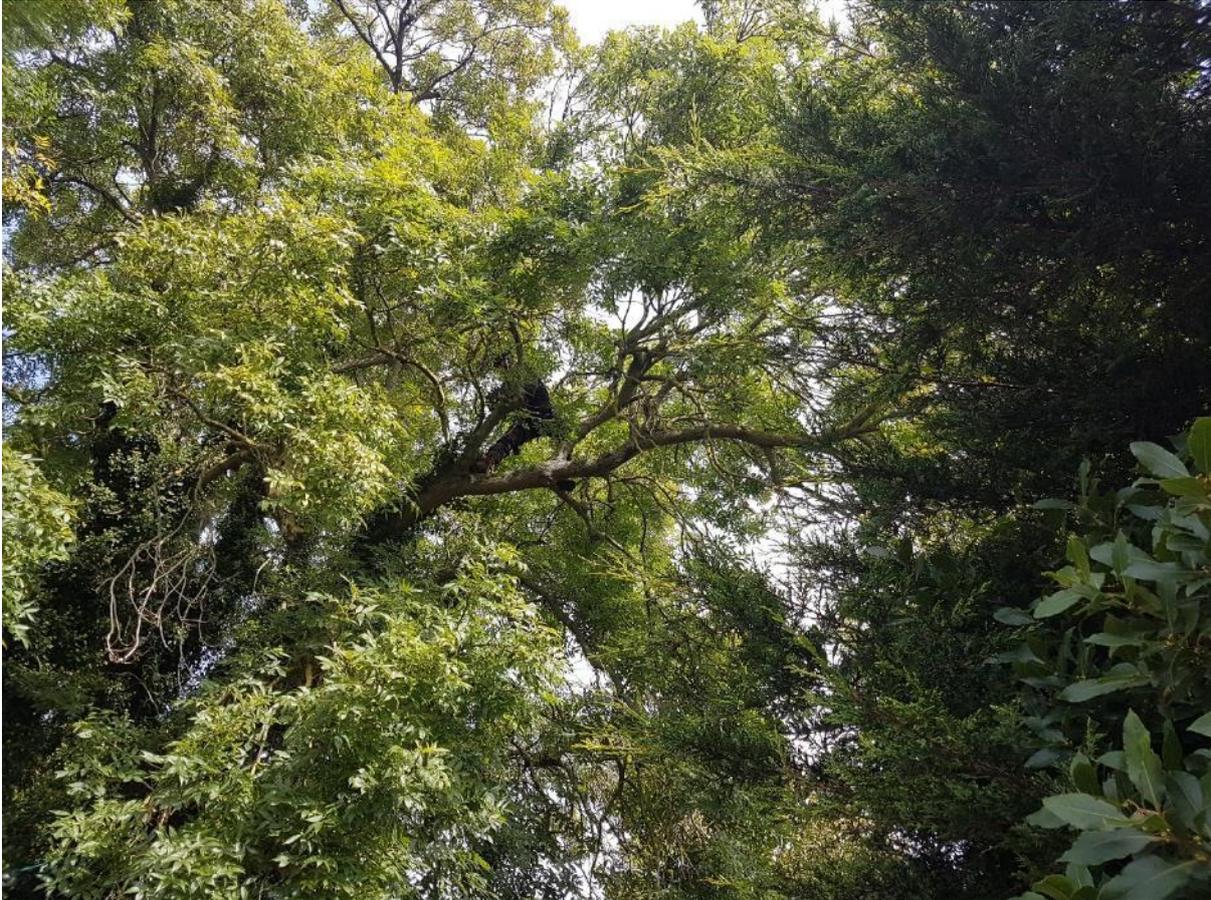
Plate 3-15: 1. Ash being searched

In summary one mature ash showed definite bat potential but supporting features suitable for use by singleton bats thus was initially ranked 2. Chainsaw cuts, tear outs were visible alongside considerable ivy cover. A branch cut shows lifted bark whilst several pruning cuts were visible. After the full survey the tree was downgraded to 3 due a lack of good prf features.

| Date: 11 <sup>th</sup> Sept 2019 | | Survey Title: Bradys Pub | | |
|---|---|--|---|---|
| 1 ash | Removal | <b>Prior to 'at height' survey</b><br>Mature tree with several potential features. Chains cuts, tear outs and ivy. A branch cut shows lifted bark whilst several pruning cuts were visible. | Conduct full prf survey. | 2 |
| | | <b>After 'at height' survey</b> <ul style="list-style-type: none"> <li>Branch stump cavity was not deep.</li> <li>A small rot feature at base of tree does not form cavity.</li> <li>A search of a broken branch showed no cavity.</li> <li>Multiple pruning cuts were examined however no cavities were found.</li> <li>Ivy was thoroughly examined with the aid of thermal imaging however no bats were found. Much of the ivy, although thick formed porous mats that were quite damp.</li> </ul> | Cut tree prior to bird breeding season. | Downgraded to 3 after inspection. |

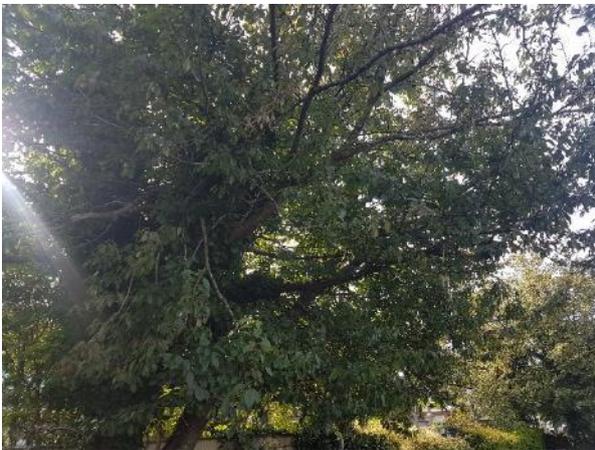
Plate 3-16: 2. Cherry

| 3 Cherry | Removal | <b>Prior to 'at height' survey</b><br>Mature tree with some features including peeling bark. One branch has a hazard beam prf. | Cut tree prior to bird breeding season. | 2 |
| | | <b>After 'at height' survey</b> <ul style="list-style-type: none"> <li>Hazard beam prf showed very limited potential as cavity had not developed upwards yet.</li> <li>Lifting bark found on a damaged branch did not show sufficient depth to host a bat roost.</li> </ul> A search of the upper sections showed a distinct lack of features with most damage occurring on lower branches. | Cut tree prior to bird breeding season. | Downgraded to 4 after inspection. |

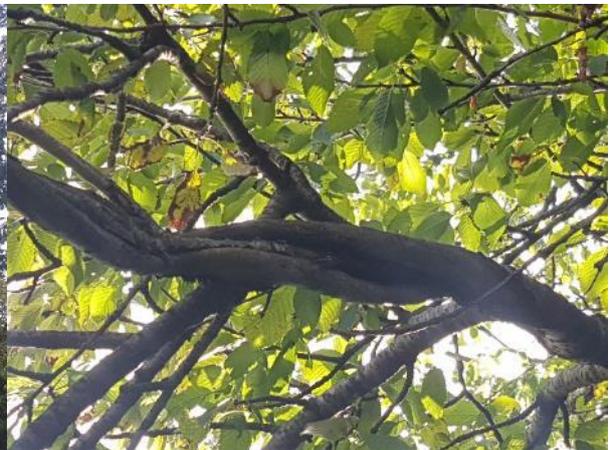
Plate 3-17: Potential prf

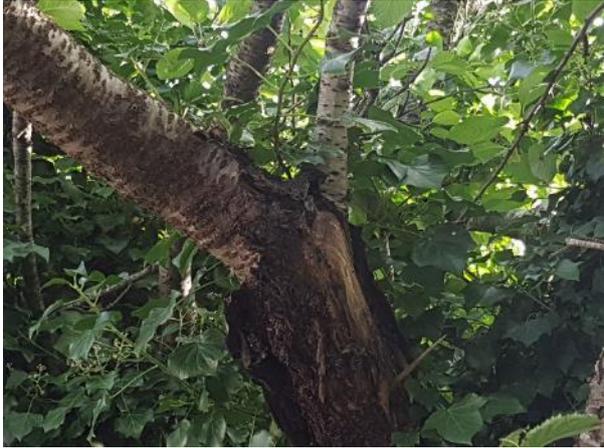
Plate 3-18: Potential prf
